## Union of an intra-articular distal radius fracture after successive failures of three locking plates: a case report

**Abstract** We report a case of a 30-year old male, who presented with a right distal radius intra-articular fracture complicated by compartment syndrome. He was treated with fasciotomies and fracture fixation with a 3.5 mm LCP (Synthes™), followed 7 days later by skin graft. Repeat radiographs 8 weeks later showed a break across the plate at the level of an unfilled screw hole over the fracture. He underwent exchange plating with a 2.4 mm LCP Distal Radius Plate (Synthes™). This revision was complicated by an infected wound dehiscence 2 weeks later requiring multiple procedures. Radiographs at 20 weeks showed broken distal screws. A second revision was performed. At 12 months, the fracture had healed clinically and radiologically, but the three distal screws had broken. We discuss the multifactorial failures of these three attempts at osteosynthesis, and which factors helped achieve osseous union. We also discuss the literature on volar locking plate breakage and conclude with the recommendations to avoid this rare complication.

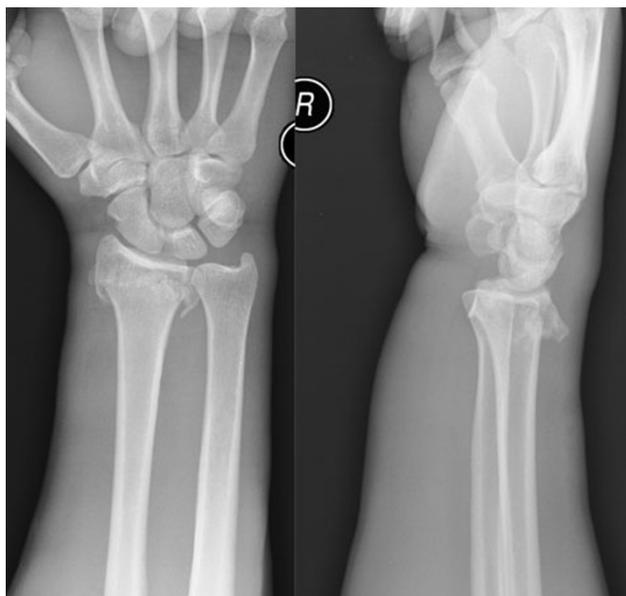
dominant right hand. He sustained a closed, dorsally angulated intra-articular fracture of his right distal radius (AO 23-C2) with extensive soft tissue swelling (Fig. 1). He was a skilled labourer with a past history of intravenous drug abuse, and ongoing mental health issues. He had smoked 20 cigarettes daily for the past 12 years.

**Fig. 1** Radiographs after injury, showing the distal radius fracture

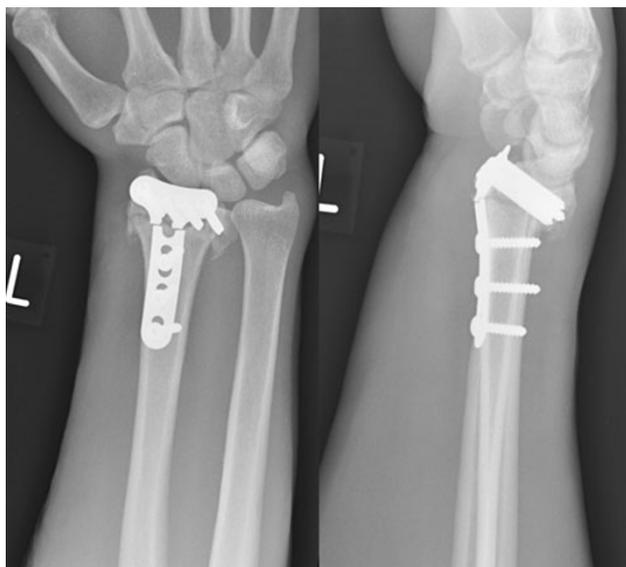
When reviewed in fracture clinic 6 weeks post-operatively, he complained of worsening wrist pain. Radiographs revealed a transverse break across the plate, at the level of the distal Combi-hole, directly overlying the fracture site (Fig. 2). Routine blood investigations at this stage showed normal white cell count and C-reactive protein. There were no overt clinical signs of infection. The patient refused to have his fracture managed with an external fixator. He also refused to consent to iliac crest bone grafting at this stage. He received a revision fixation using a 2.4 mm LCP Distal

**Fig. 2** Radiographs at 6 weeks after the index procedure. Broken plate

Radius Plate (Synthes<sup>TM</sup>, Solothurn, Switzerland), which has an 8-hole head configuration for the distal fragment. The plate was applied to the radial shaft with four bicortical screws, while four locking screws were inserted into the distal fragment. No macroscopic infection was seen in the bone or in the soft tissues intra-operatively. The wrist was immobilised in a plaster splint.

include patient factors (non-compliance, smoking and poor personal hygiene), biological factors (fracture fragmentation, impaired circulation, bruised muscular envelope and secondary infection) and mechanical factors (no bone graft, unfilled screw holes and insufficient immobilisation). The original plate was applied across a multifragmented fracture, surrounded by bruised muscular mass. The skin graft and its subsequent infection precluded immobilisation in a

full cast. The patient did not adhere to non-weight-bearing instructions. Mechanical stresses were therefore able to build up in the vicinity of the unfilled Combi-hole, surrounded by a biologically unfavourable environment. This presumably led to the first plate failure and non-union.

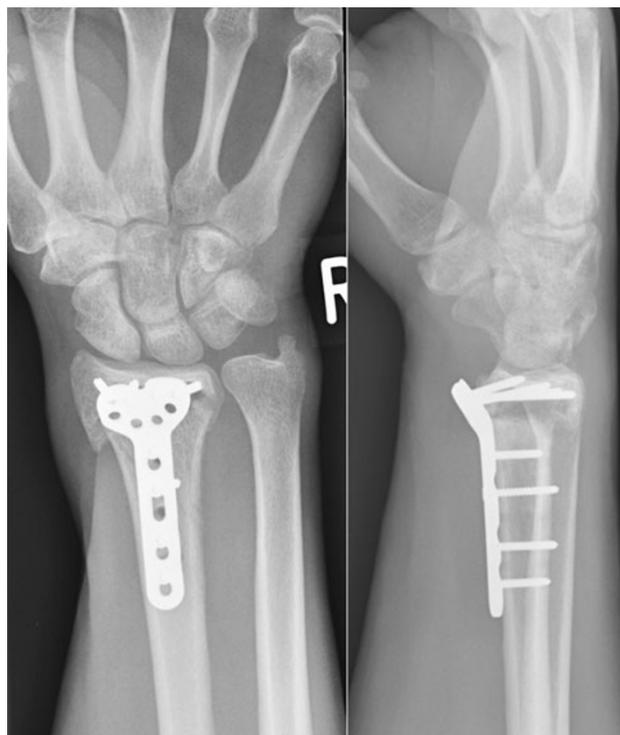
**Fig. 3** Radiographs at 20 weeks after the first revision procedure

He was followed up in clinic with serial radiographs, at 8, 14 and 20 weeks after the first revision osteosynthesis (Fig. 3). While these showed that the implant was still holding the fracture in an acceptable position, there was no discernible callus. At 26 weeks, his wrist was still painful and looked deformed. Radiographs at this appointment showed that the revision fixation had failed, this time with breaks across all the distal fragment screws (Fig. 4).

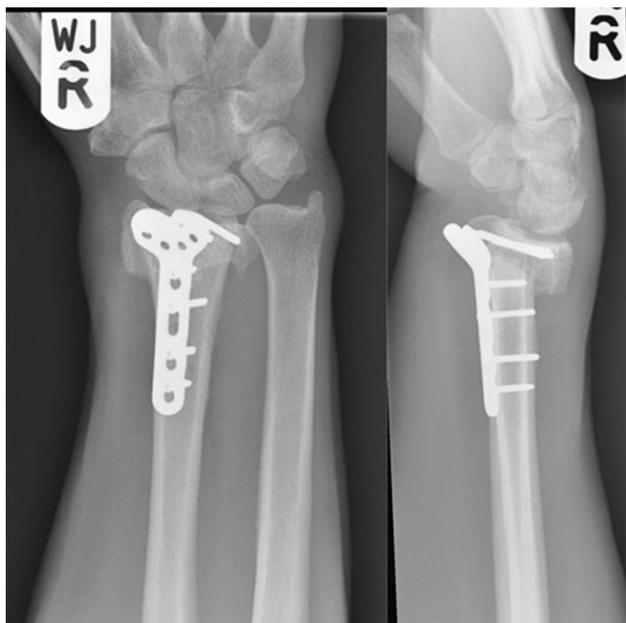
**Fig. 4** Radiographs at 26 weeks after the first revision procedure. Broken screws

A second revision fixation was performed with another 2.4 mm LCP Distal Radius Plate (Synthes<sup>TM</sup>, Solothurn, Switzerland). The patient consented to iliac crest bone graft this time. The wrist was re-immobilised in a plaster cast post-operatively. He was non-tender over the distal radius when examined at 6 weeks after this second revision procedure, and all the wounds had healed well (Figs. 5, 6). Immobilisation was continued for another 4 weeks. At the last follow-up at 12 months after the second revision fixation, the fracture had united clinically and radiologically. The three distal screws had, however, broken, without the plate coming off the bone (Fig. 7). His flexion–extension (FE) arc was 90°, with radial–ulnar (RU) deviation arc of 30°; all movements were pain-free. His grip strength was 70% of the opposite wrist. He had regained employment

Once the infection became ‘deep-seated’ and refractory to antimicrobial therapy, the fracture biology was impaired significantly. Bony integrity was compromised because of the multifragmentation, and the patient had refused to have a bone graft. He was also non-compliant again with weight-bearing instructions. Thus, the first revision plate was subject to exaggerated stresses again. Since the proximal portion of the locking plate was now more stable with all holes filled with screws, the stresses now concentrated at the four distal screws, causing them to break. If a bone graft had been used at that stage, and all the available screw holes for the distal fragment had been filled up, the load transmission would intuitively have been more evenly distributed, thereby lessening the stress concentration. Unfilled screw holes in the distal fragment have previously been suggested as the mechanical factor responsible for screw breakage in a Aculock<sup>®</sup> locking plate (Acumed<sup>™</sup>, Hillsboro, OR, USA) [11]. This also explains the breakage of the screws in the second revision plate. However, improved biological and patient factors allowed the fracture to unite.

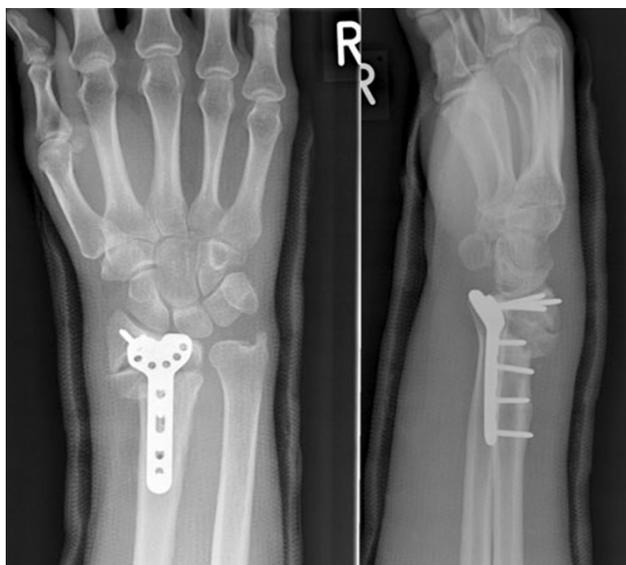
**Fig. 5** Radiographs at 6 weeks after the second revision procedure (with bone graft)

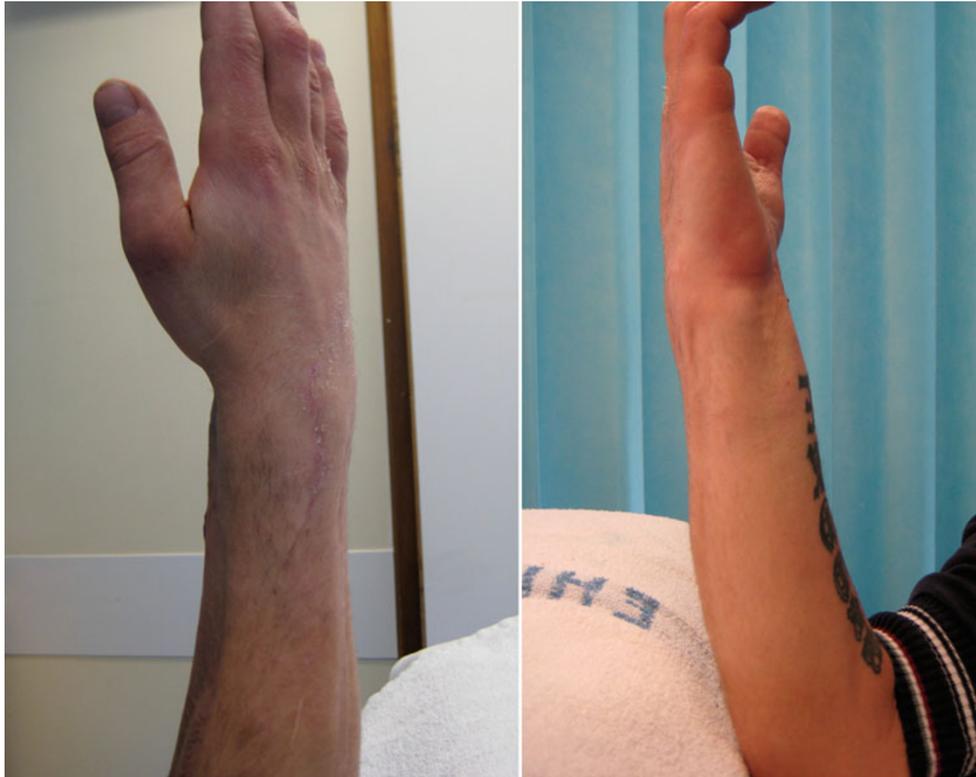
**Fig. 6** Clinical examination at 6 weeks after the second revision

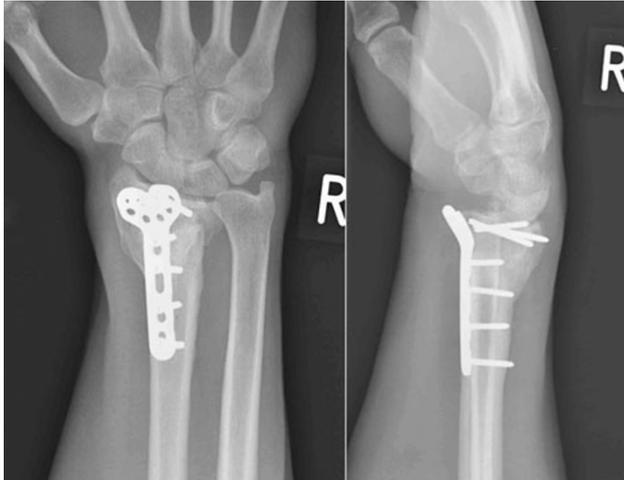
**Fig. 7** Radiographs at 1 year after second revision

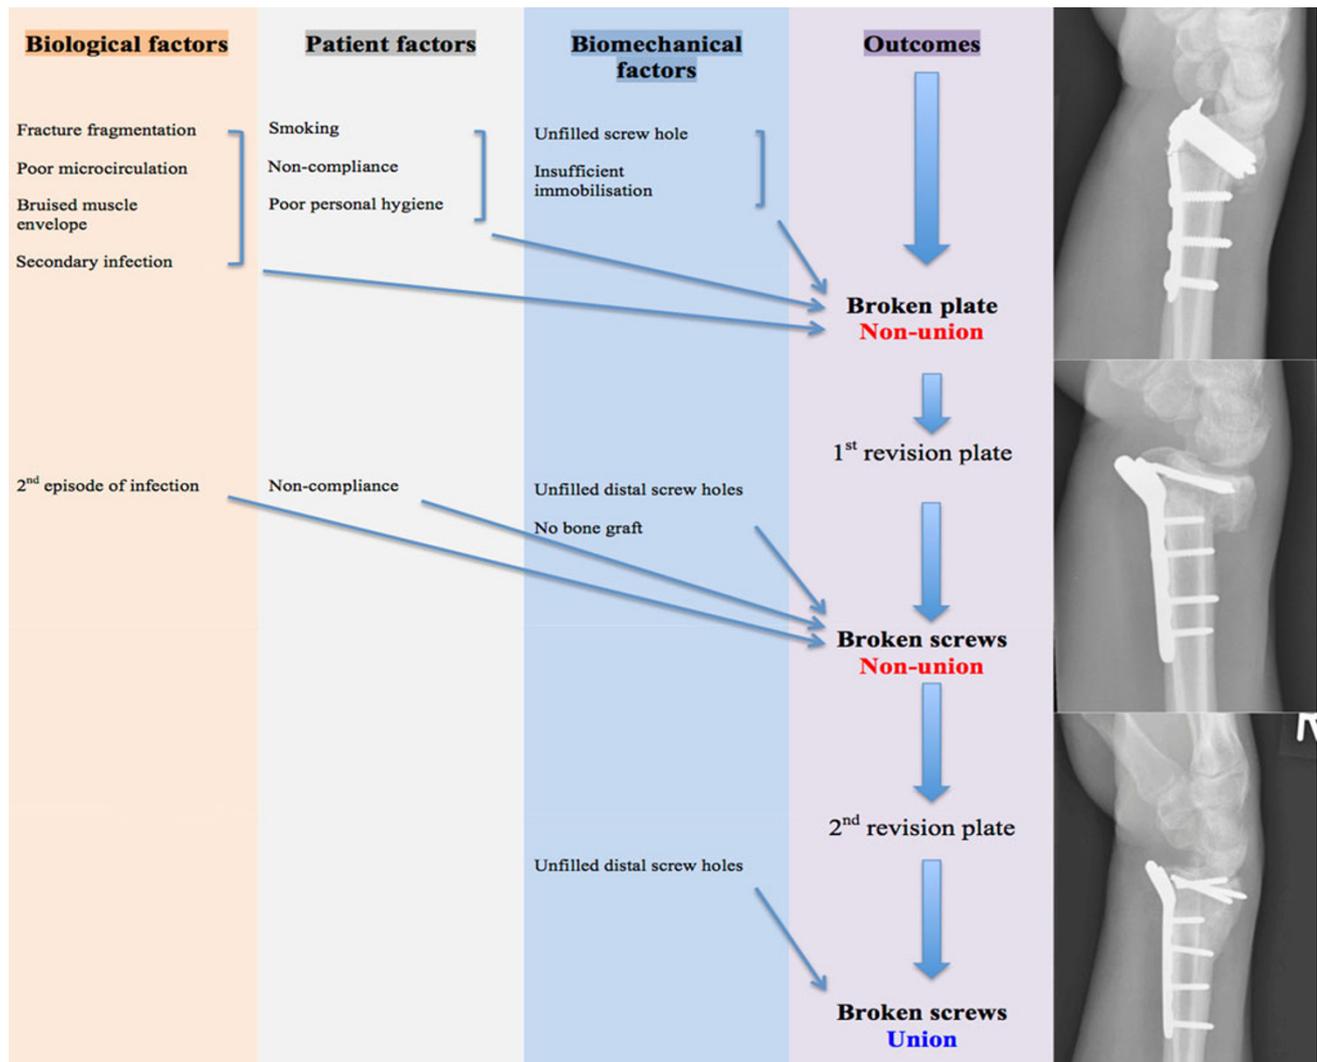
The failure of the original procedure in the presented case seems multifactorial (Fig. 8). These possible causes

**Fig. 8** Suggested causes for sequential failures of the three plates

We feel that patient selection is important to ensure success of osteosynthesis. Additionally, both biological and biomechanical factors need to be considered when deciding on the type and mode of plate, utilisation of use of bone graft and the duration of immobilisation.
